NRL Memorandum Report 4075

## Failure Causing Defects in Ceramics: What NDE Should Find

R. W. RICE, J. J. MECHOLSKY, S. W. FRIEMAN, AND S. M. MOREY

October 30, 1979

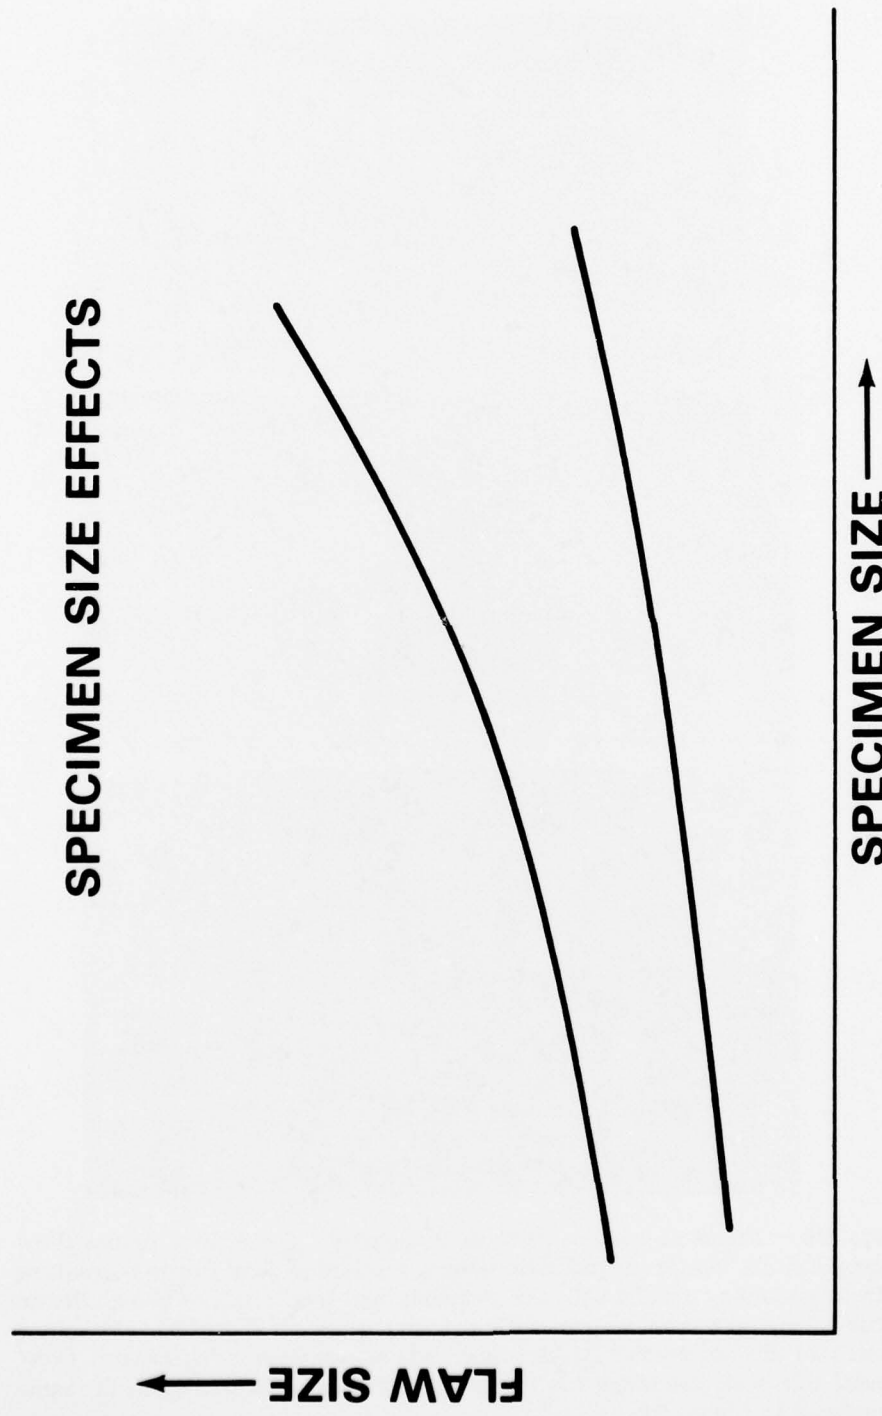
Fig. 19 — Schematic illustration of the effects of specimen size on flaw size. Because most, if not all, sources of flaws are associated with probabilistic or statistically controlled phenomenon, flaw sizes generally increase with specimen sizes. The degree of this increase depends upon a variety of parameters including both the character of the material as well as the nature of the processing. Shape effects can also be important in the different variation of flaw size with specimen size which are in turn related to the variation of strength with specimen size and shape.

Three general factors should be noted in considering the size and type of flaw character that will control the strength behavior of ceramics in addition to the points made in the previous section. These three factors are the size of the specimen, its shape and its cost. The introduction of most flaws, whether they be processing defects or machining defects, is a statistically controlled process. Thus, as the specimen size increases, the probability of having a more severe, e.g. larger flaw size increases as schematically indicated in Figure 19.
